MOLD REMEDIATION PROTOCOL

**Former YMCA Building
480 South 3rd Street
Clinton, Iowa 52732**

August 19, 2024

Moisture and Microbial Investigation Report

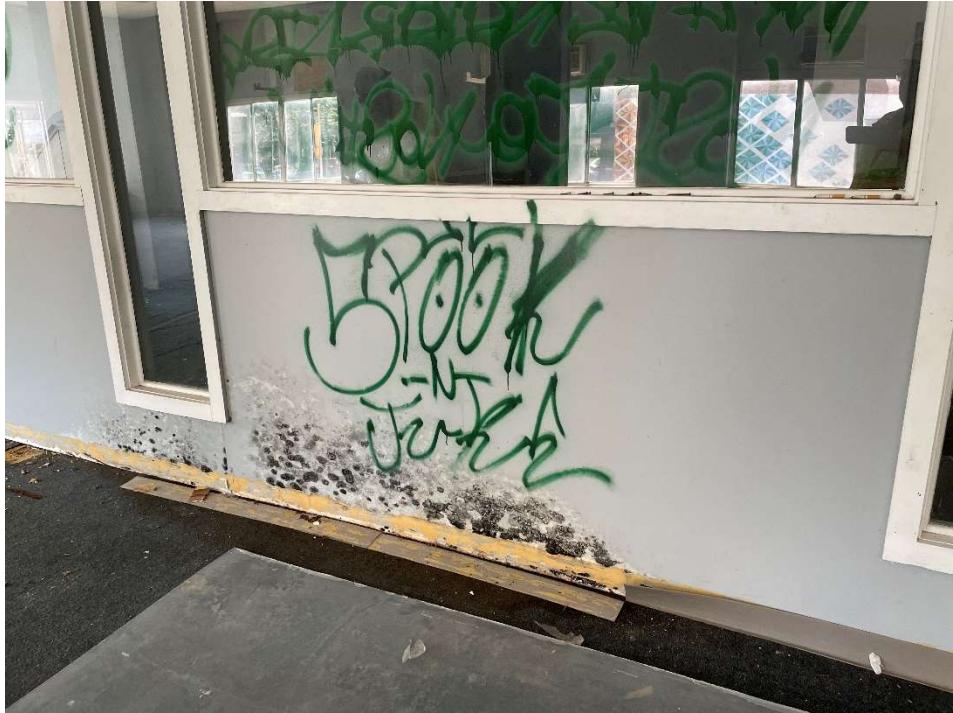
Photo 8: View of observed microbial growth along the north portion of the west wall in Room 4, first floor

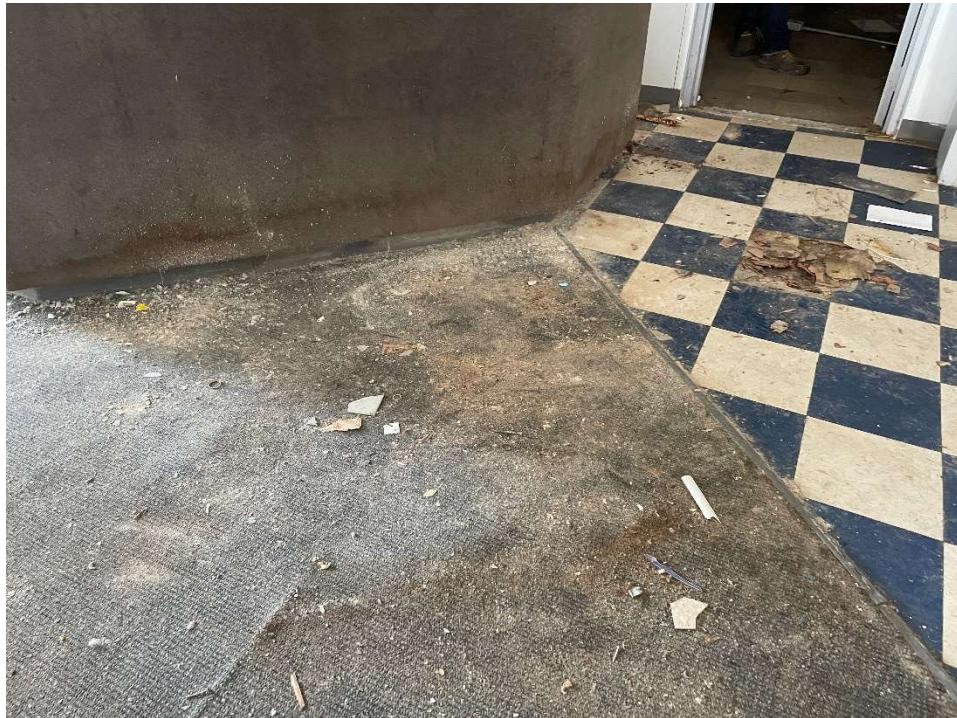
Photo 9: View of water stained flooring on first floor near Room 3/behind the counter

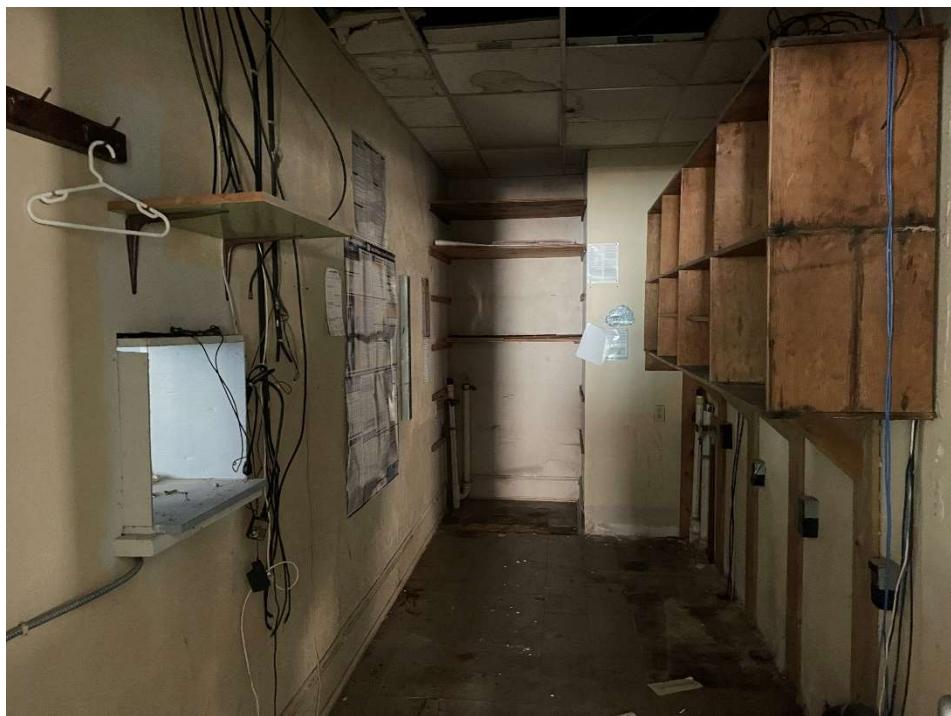
Photo 10: View of Room 3 on first floor with water stained ceiling and floor tiles

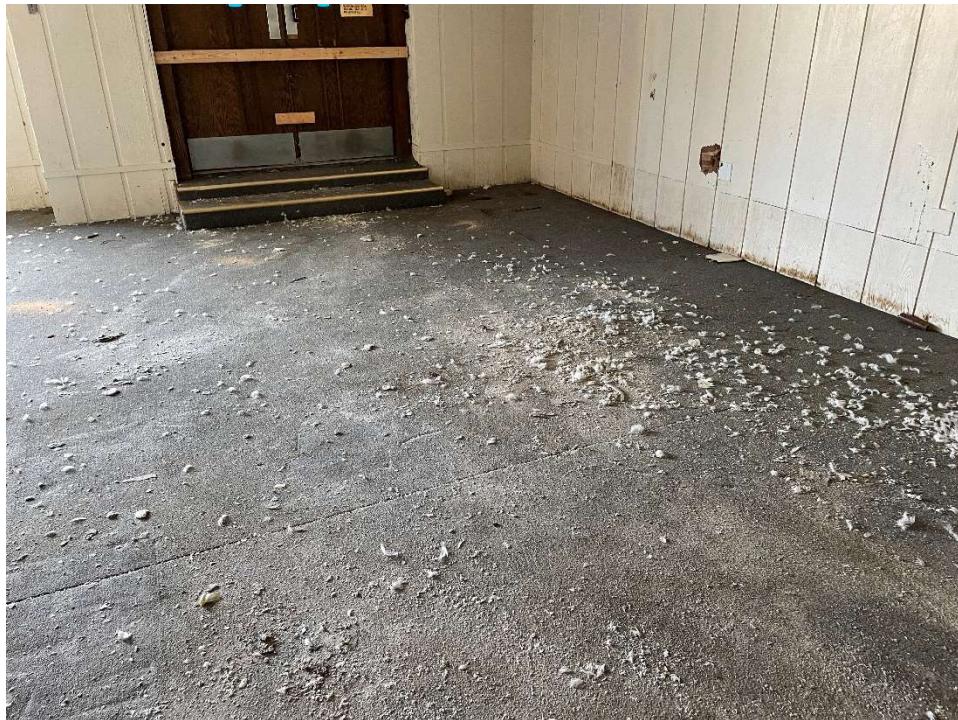
Photo 11: View near southeast corner of Room 5 on first floor with water damaged flooring and water staining on wood paneling

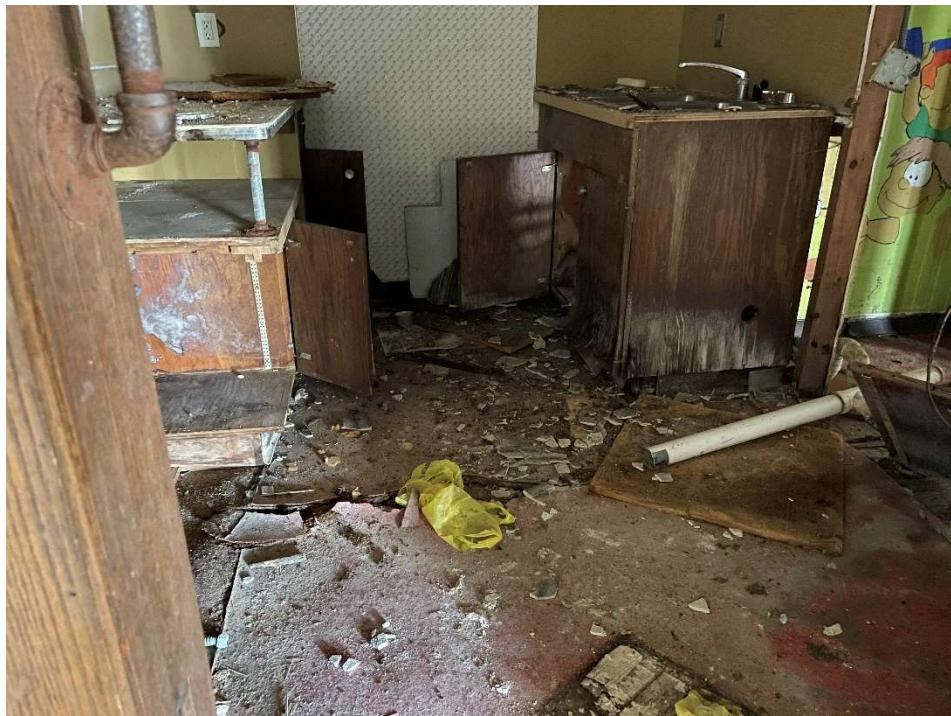
Photo 12: View of Room 6 on the first floor with water damaged materials and delaminated plaster on floor in room

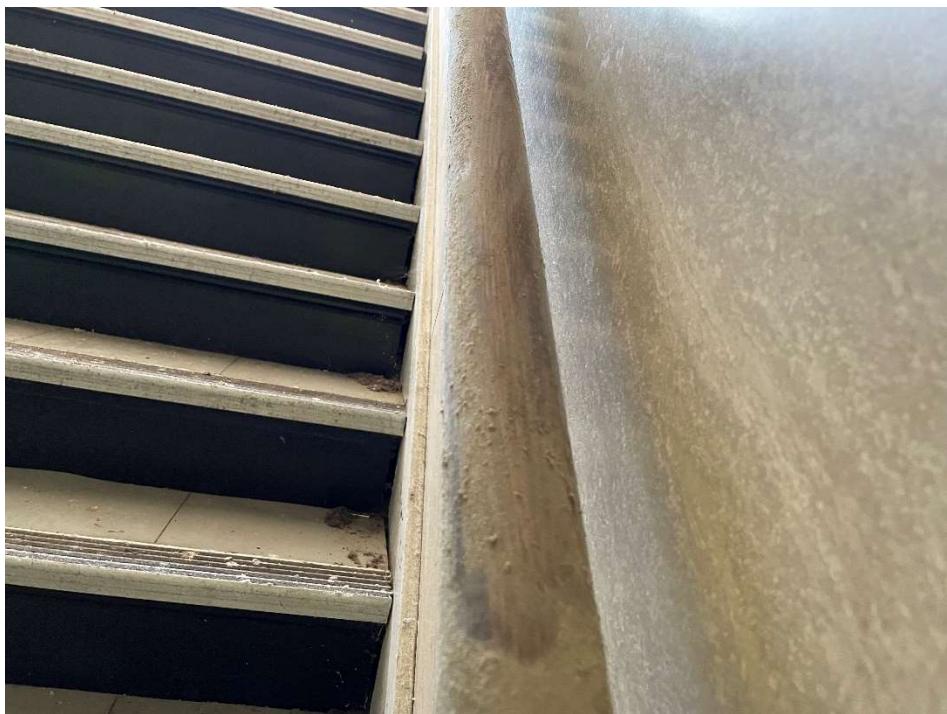
Photo 13: View of handrail leading from first floor to second floor with water damage and suspect microbial growth

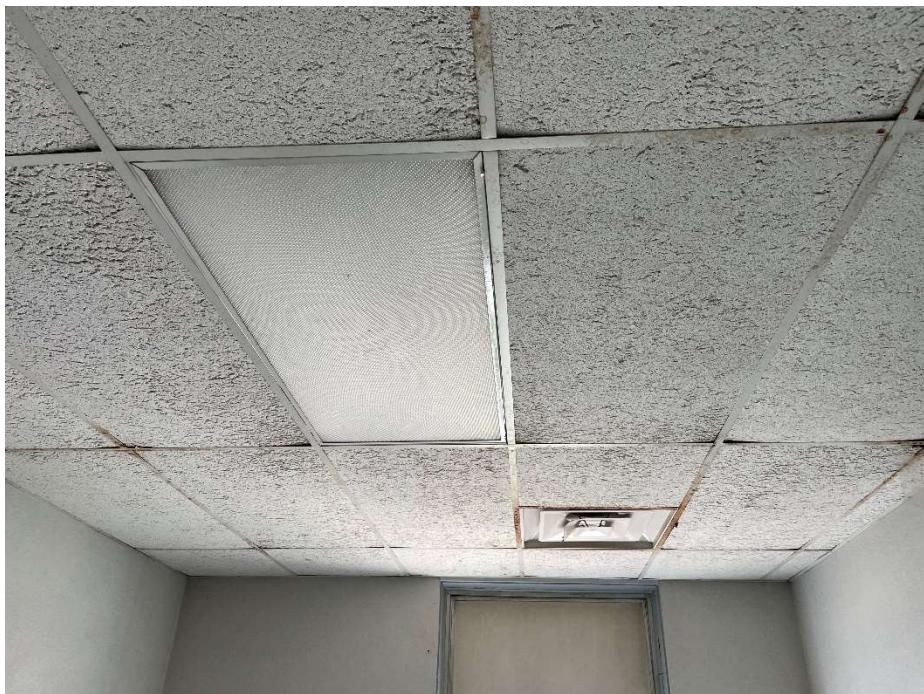
Photo 14: View of moisture-impacted ceiling tiles and ruched ceiling tile grid inside Unit 201 on second floor

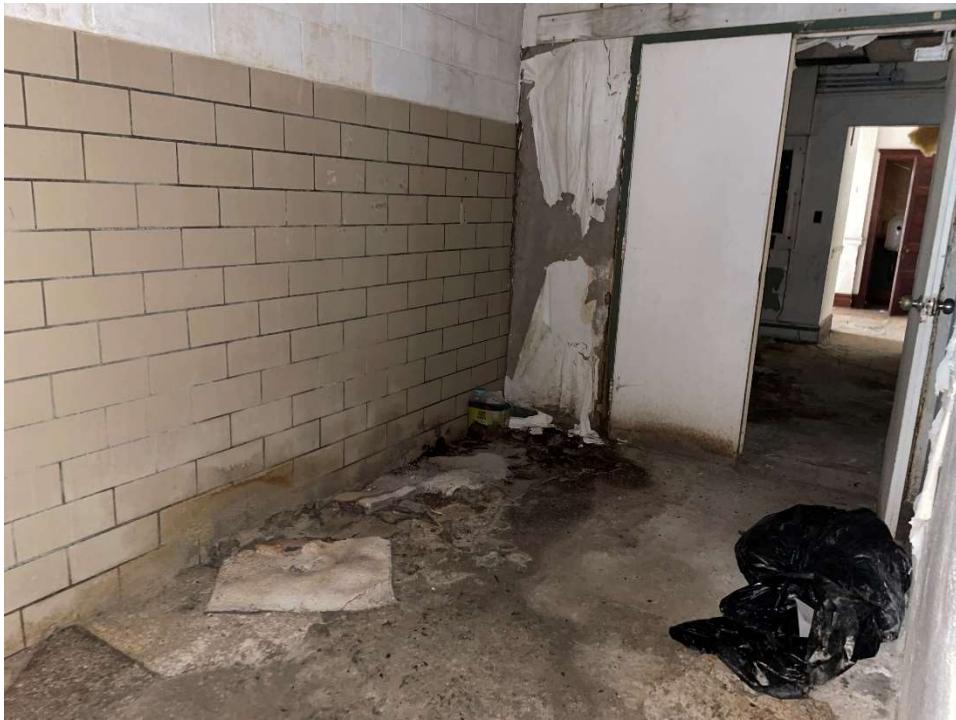
Photo 15: View of second floor north hallway showing significant water damage and staining to various materials

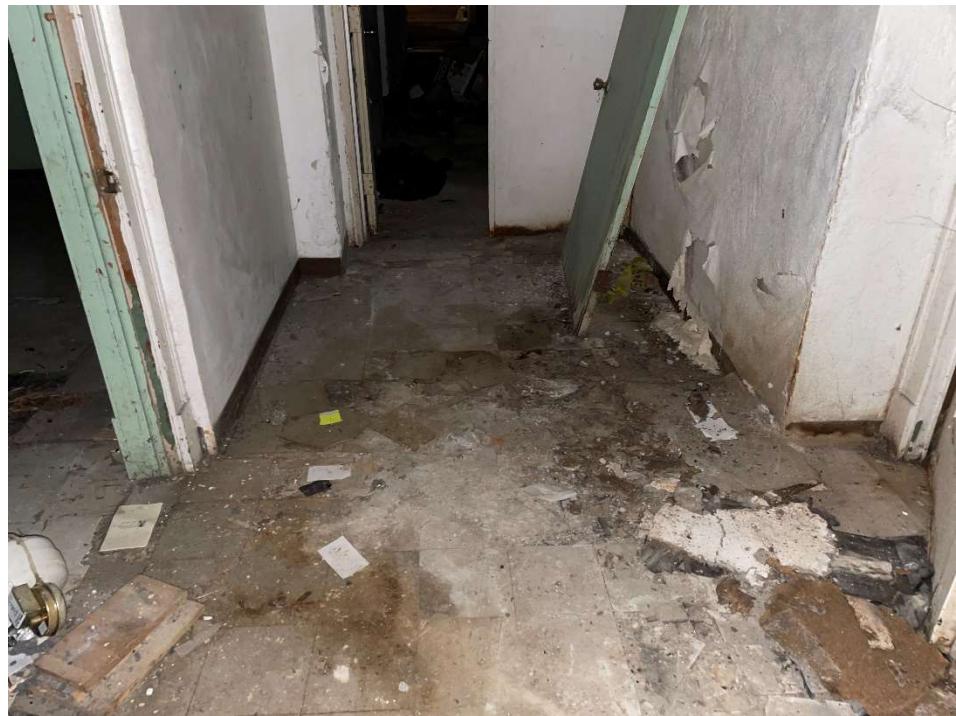
Photo 16: Alternate view of second floor north hallway area near Room 10 and significant water damaged materials

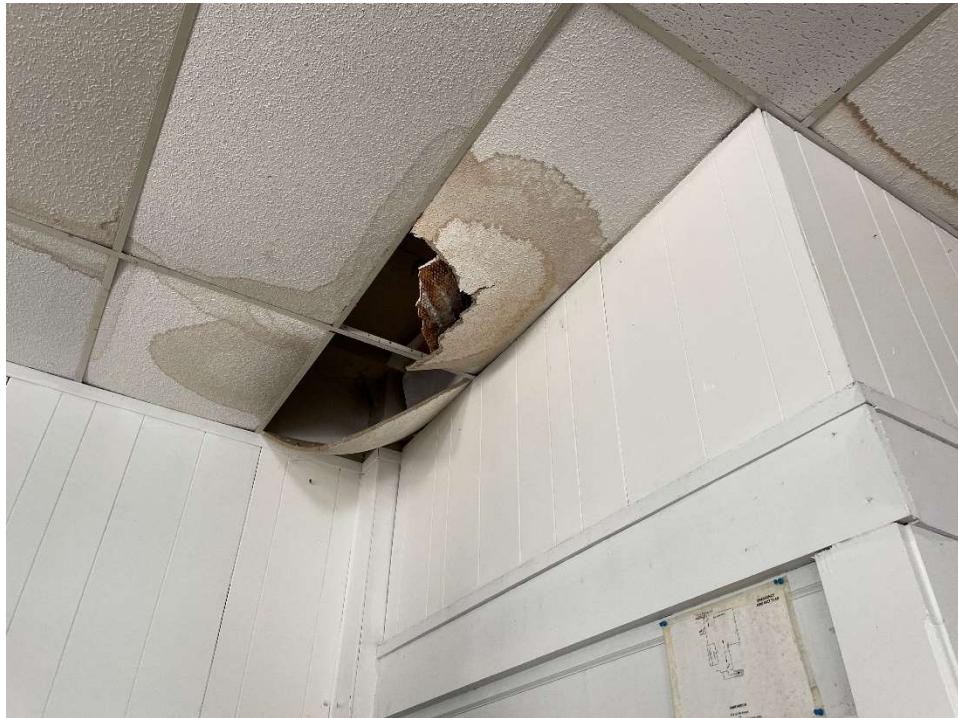
Photo 17: View of water damaged ceiling tiles at southwest corner of Room 11 on second floor

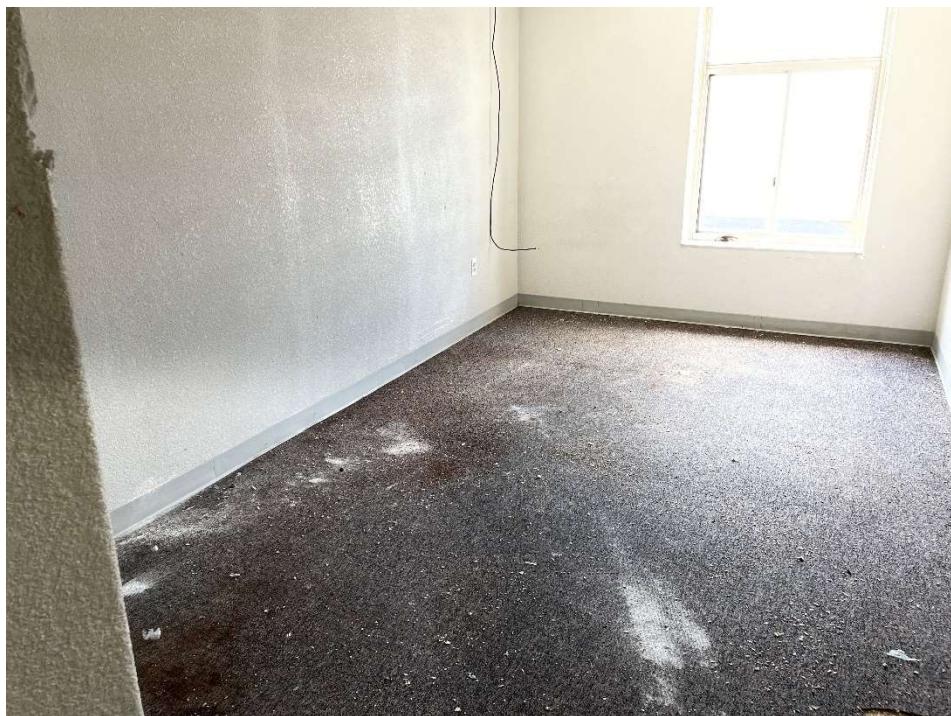
Photo 18 View of water damaged flooring in Unit 323 on third floor

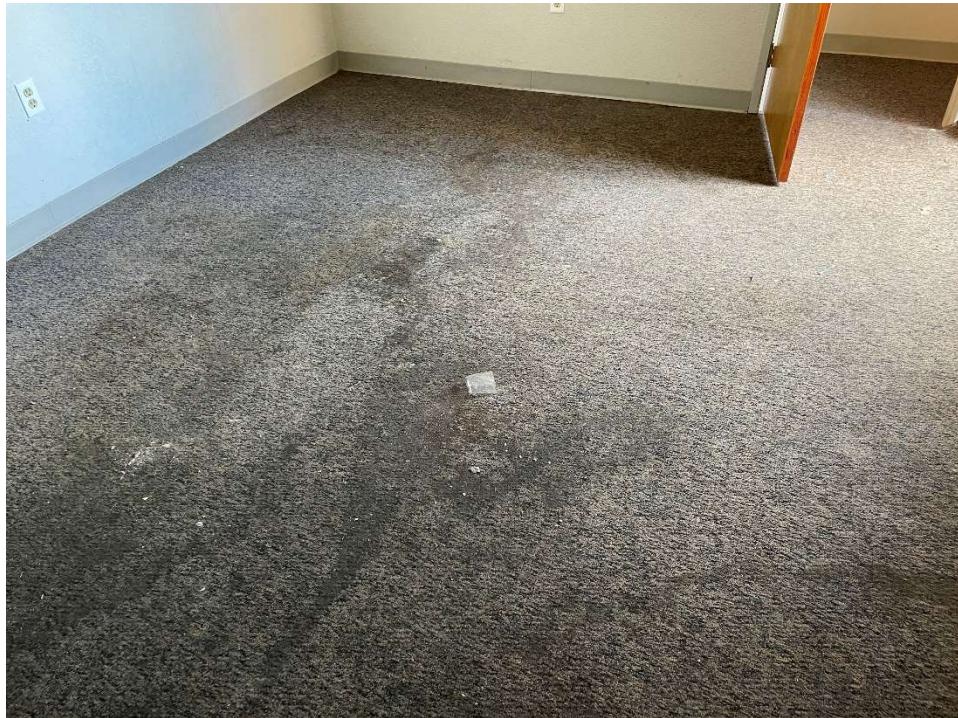
Photo 19: View of water damaged flooring in Unit 318 on third floor

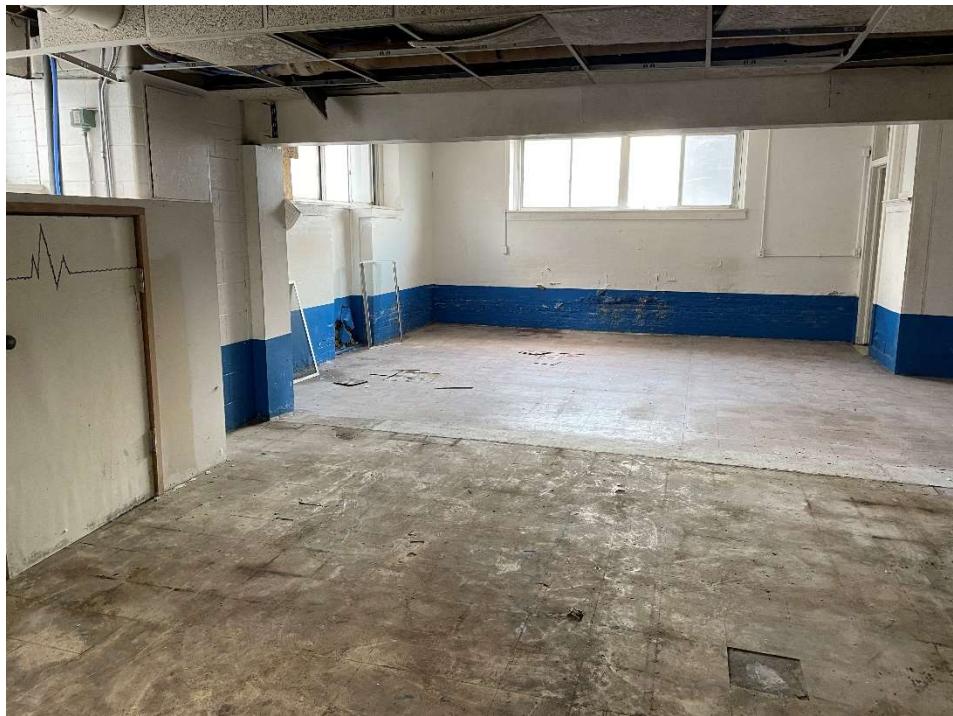
Photo 20: View of significant moisture damage on south wall of basement

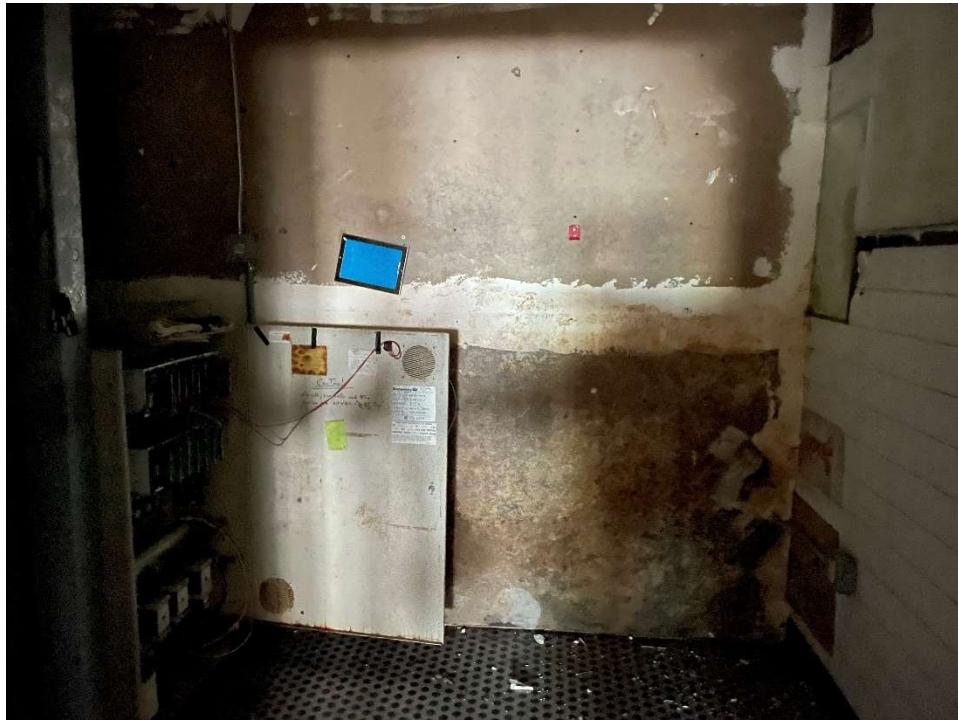
Photo 21: View of significant water damage in Room B8 in the basement

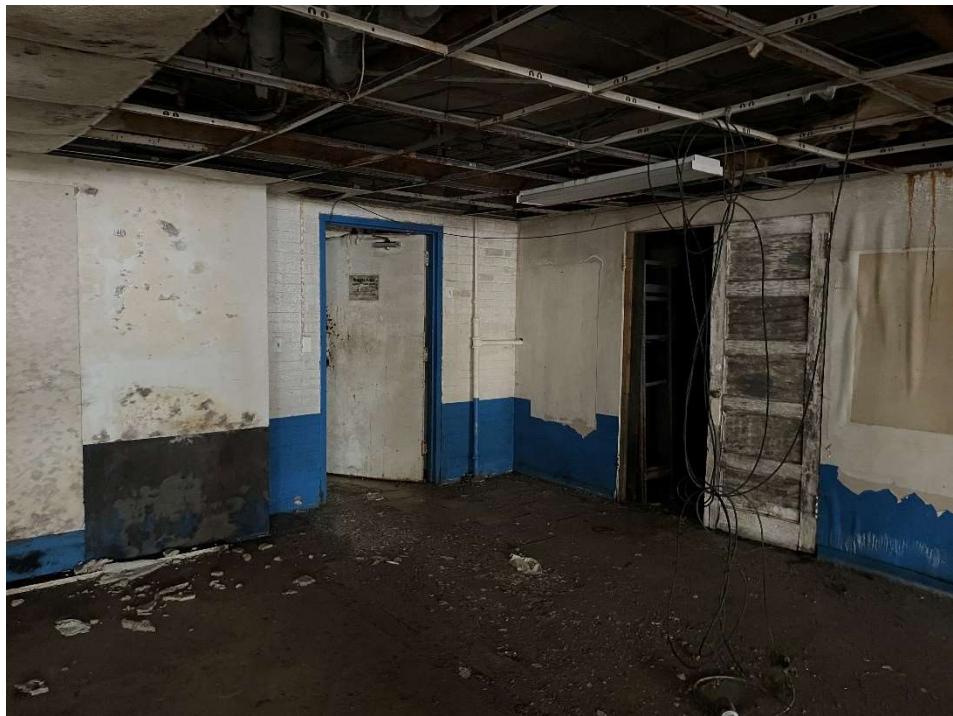
Photo 22: View of water damage and suspect microbial growth in northwest portion of basement
