Moisture and Microbial Investigation Report

**Former YMCA Building
480 South 3rd Street
Clinton, Clinton County, Iowa**

September 29, 2022

Terracon Project No. 07207086; Task 32

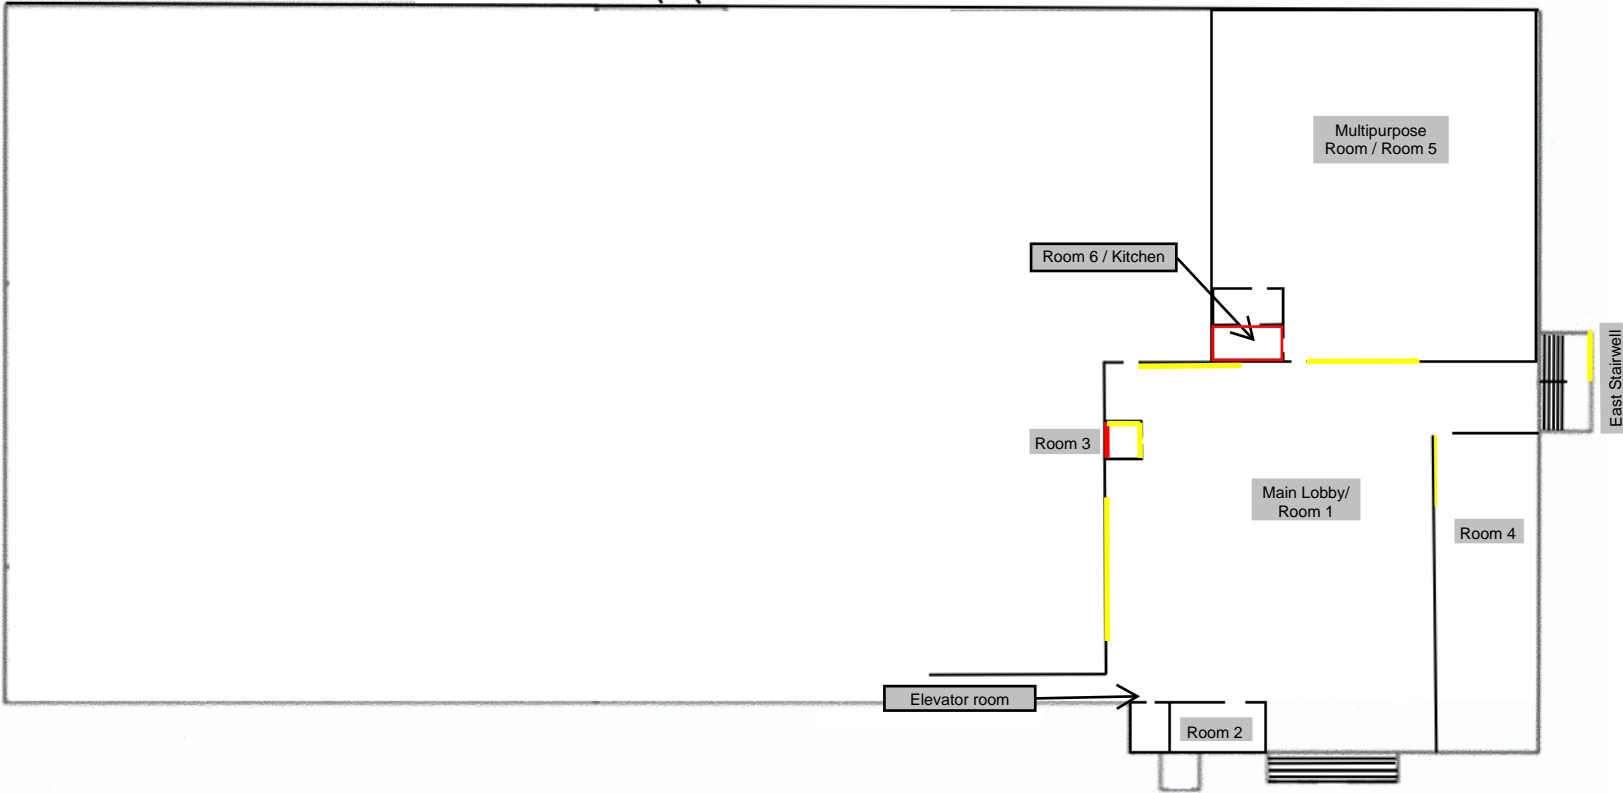
MOISTURE LOCATION MAP
1905 Building - Main Level Former YMCA – 480 South 3 rd Street Clinton, Iowa

The west wall of Room 3 and each of the four walls in Room 6 had moisture content readings in excess of 20% WME and are interpreted as Wet. At Risk moisture readings above 17% WME but below 20% WME were noted along the west and north walls and the northeast wall in Room 1, the northwest wall in Room 4, the south wall of Room 5 and the lower stairwell wall leading to the basement.

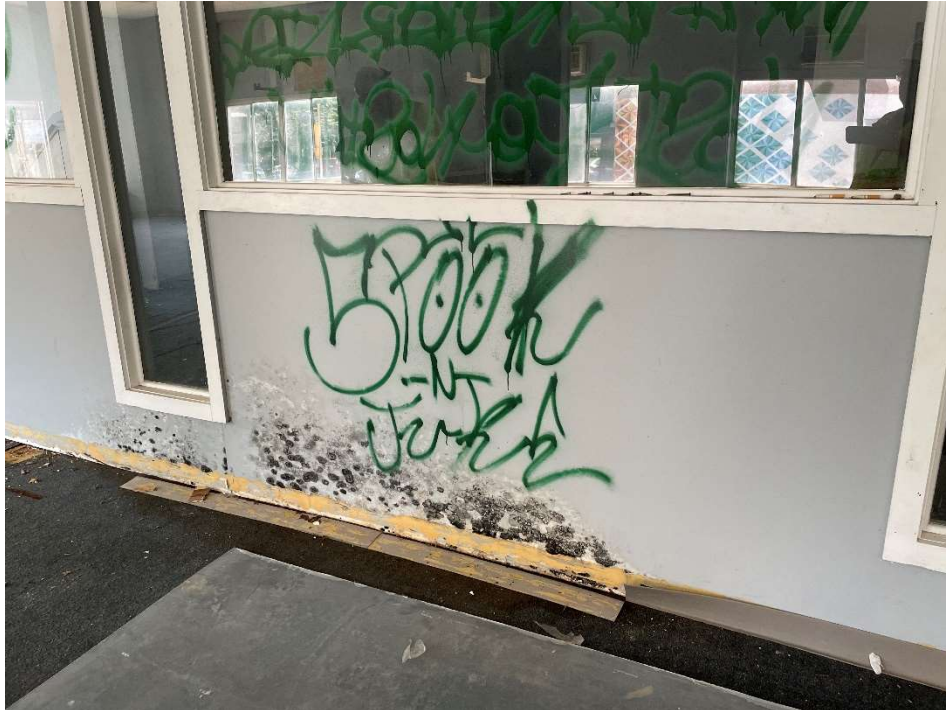
Photo 8: View of observed microbial growth along the north portion of the west wall in Room 4, first floor

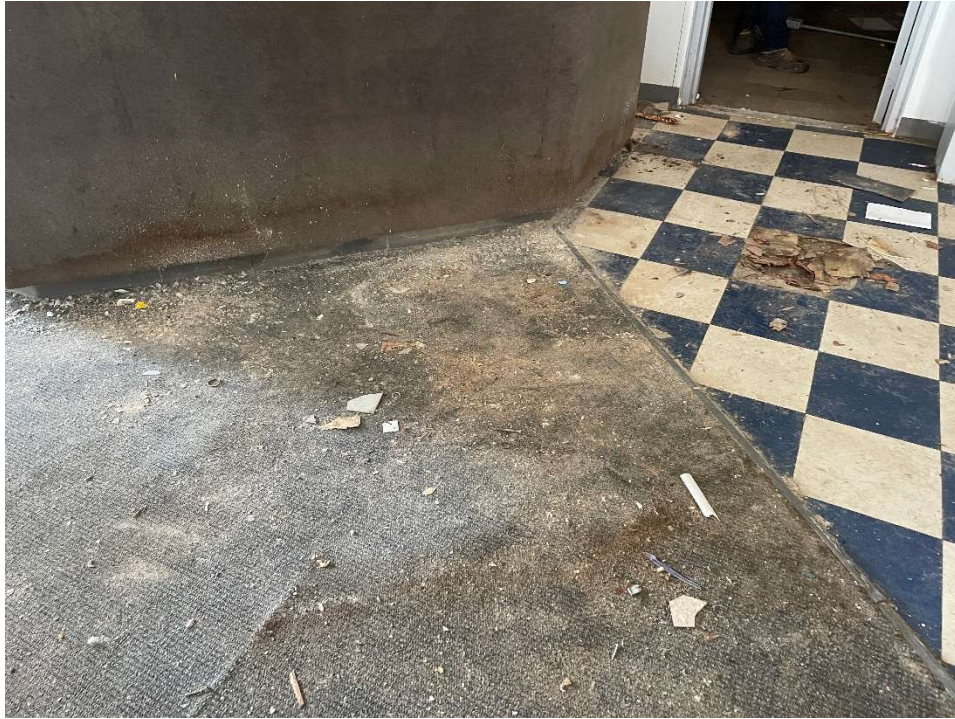
Photo 9: View of water stained flooring on first floor near Room 3/behind the counter

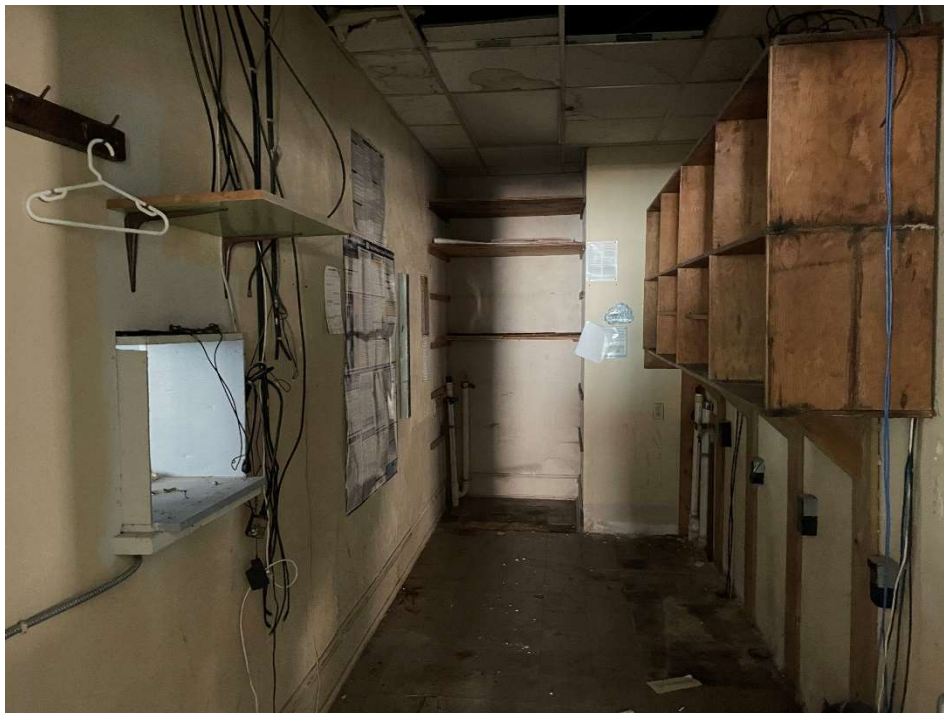
Photo 10: View of Room 3 on first floor with water stained ceiling and floor tiles

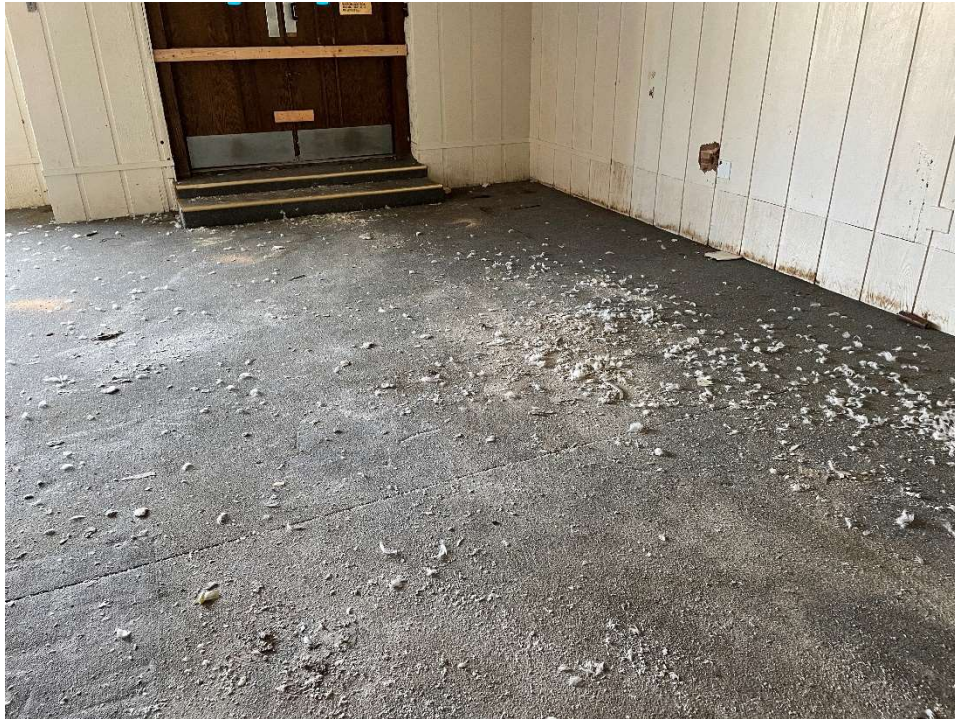
Photo 11: View near southeast corner of Room 5 on first floor with water damaged flooring and water staining on wood paneling

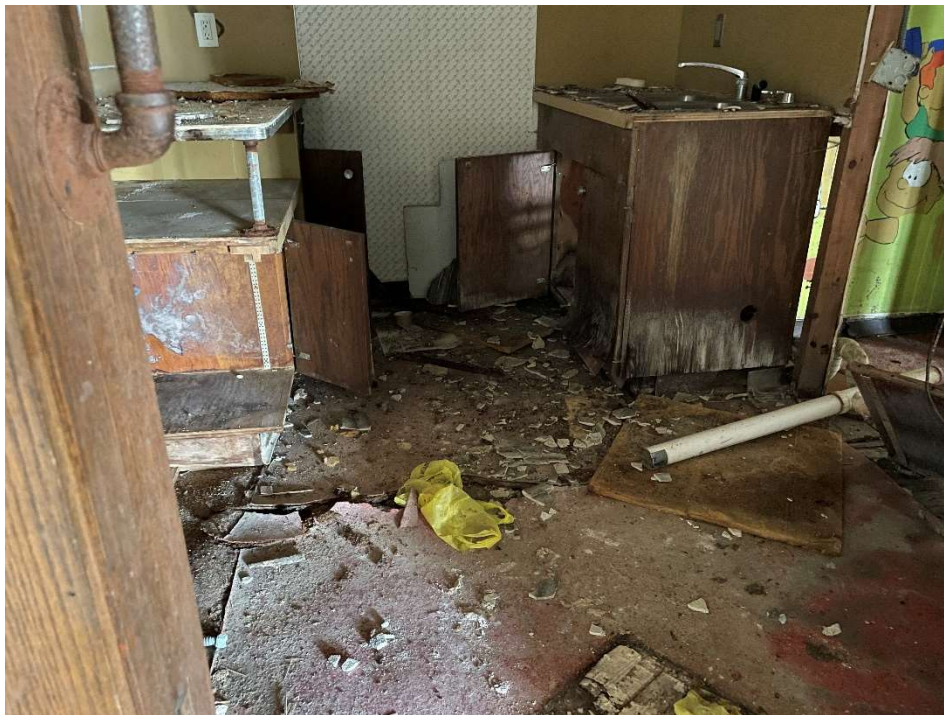
Photo 12: View of Room 6 on the first floor with water damaged materials and delaminated plaster on floor in room

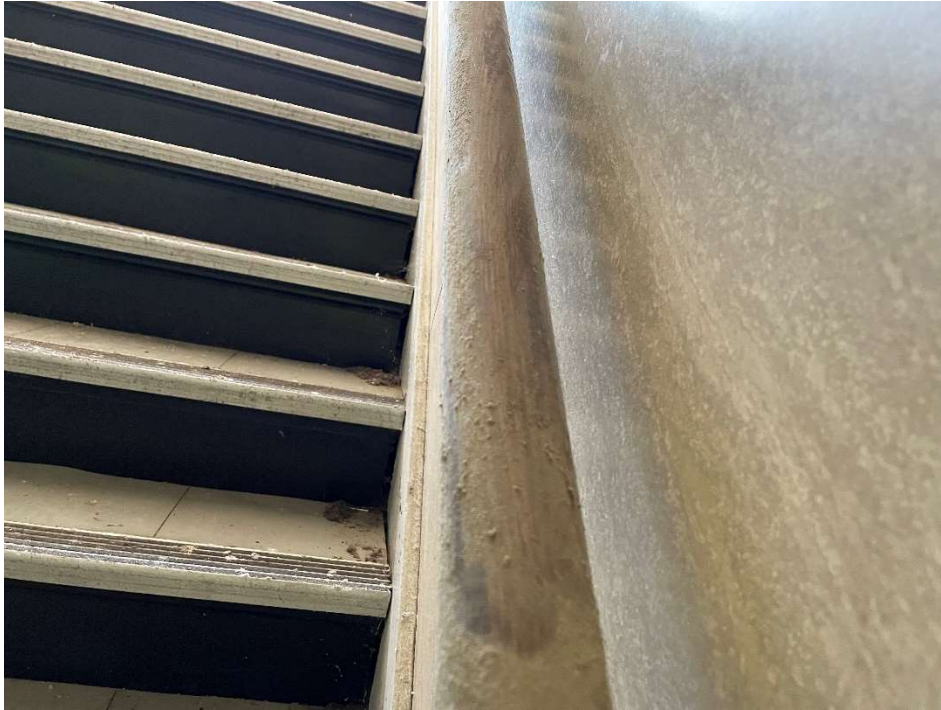
Photo 13: View of handrail leading from first floor to second floor with water damage and suspect microbial growth

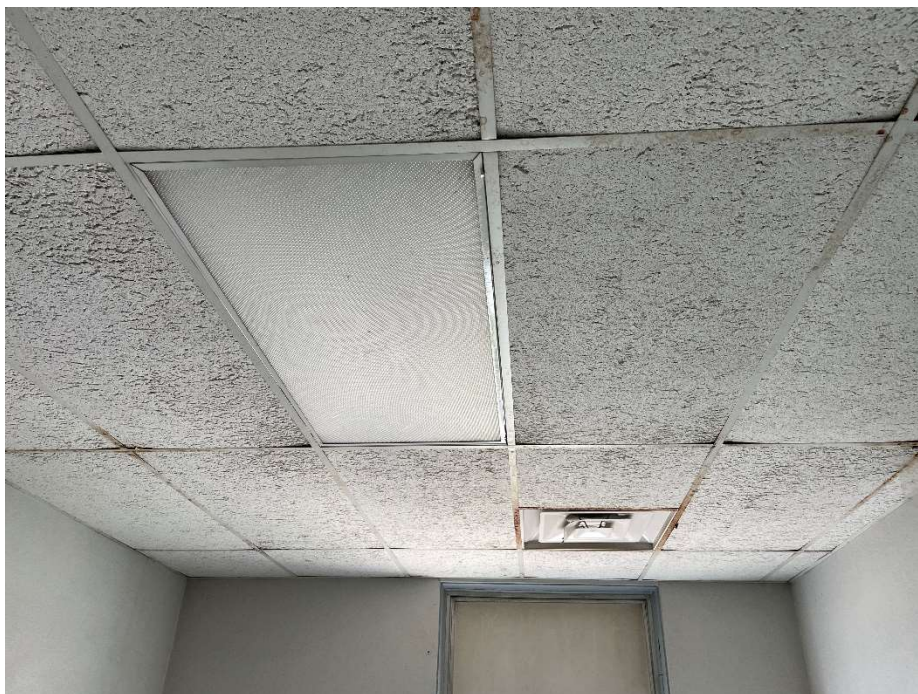
Photo 14: View of moisture-impacted ceiling tiles and ruset ceiling tile grid inside Unit 201 on second floor

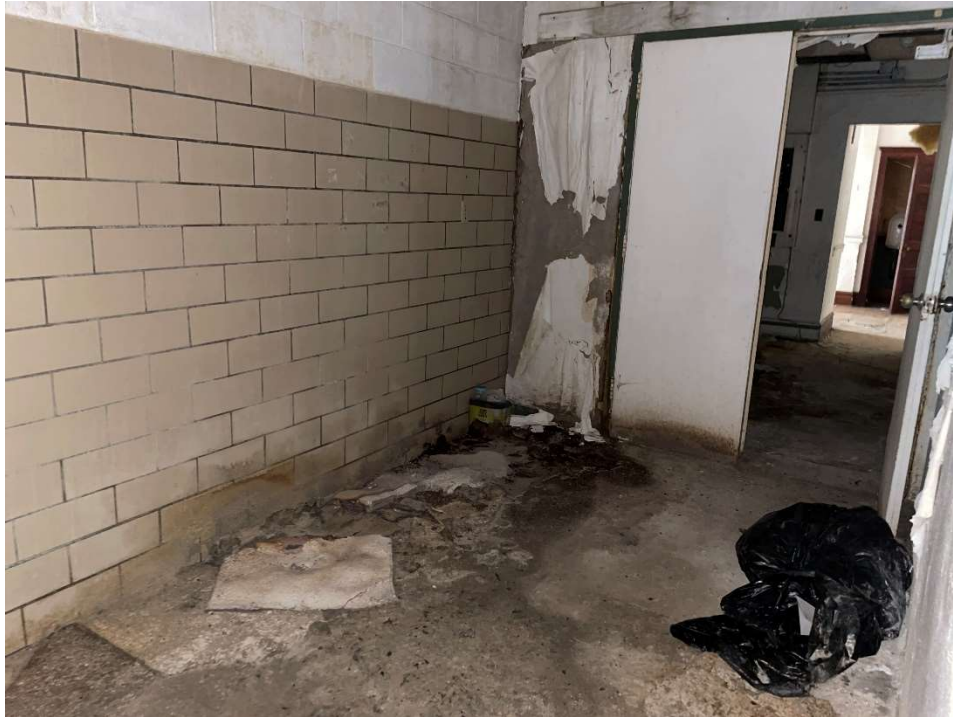
Photo 15: View of second floor north hallway showing significant water damage and staining to various materials

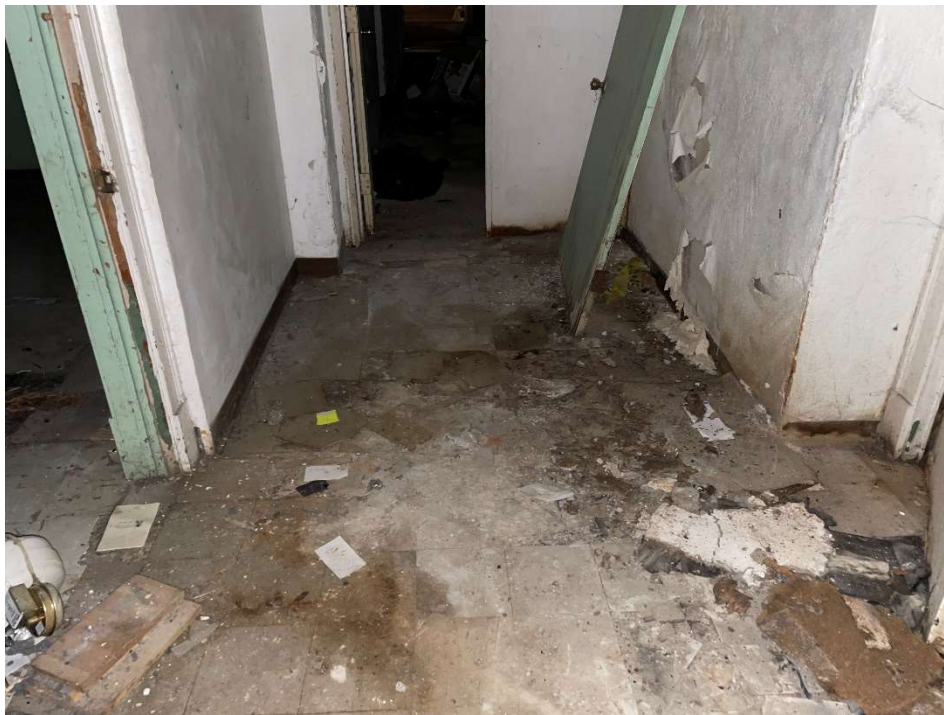
Photo 16: Alternate view of second floor north hallway area near Room 10 and significant water damaged materials

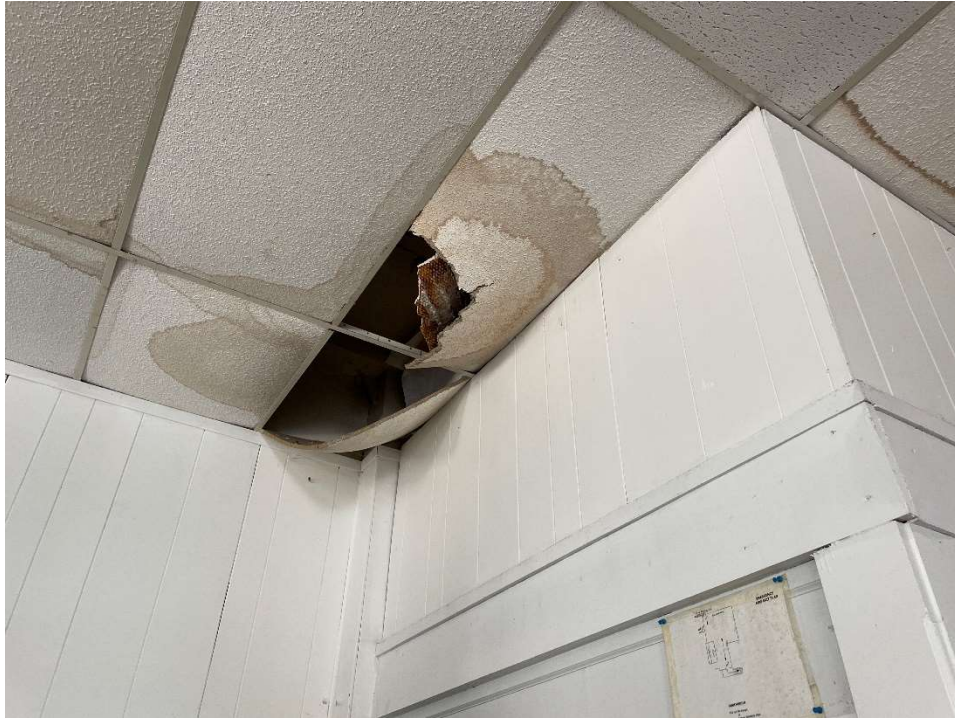
Photo 17: View of water damaged ceiling tiles at southwest corner of Room 11 on second floor

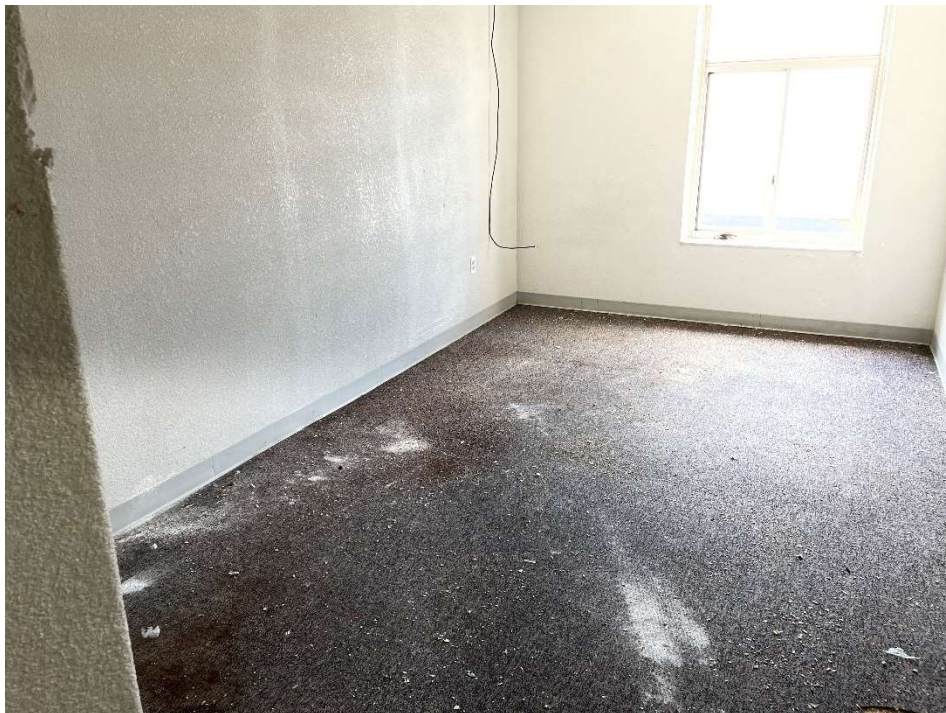
Photo 18 View of water damaged flooring in Unit 323 on third floor

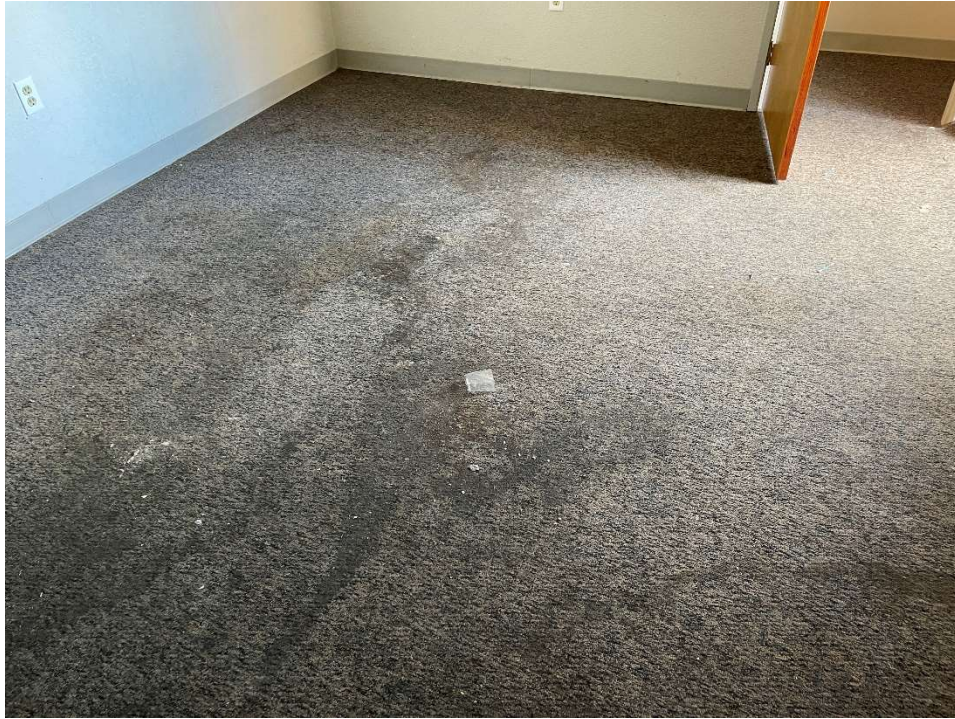
Photo 19: View of water damaged flooring in Unit 318 on third floor

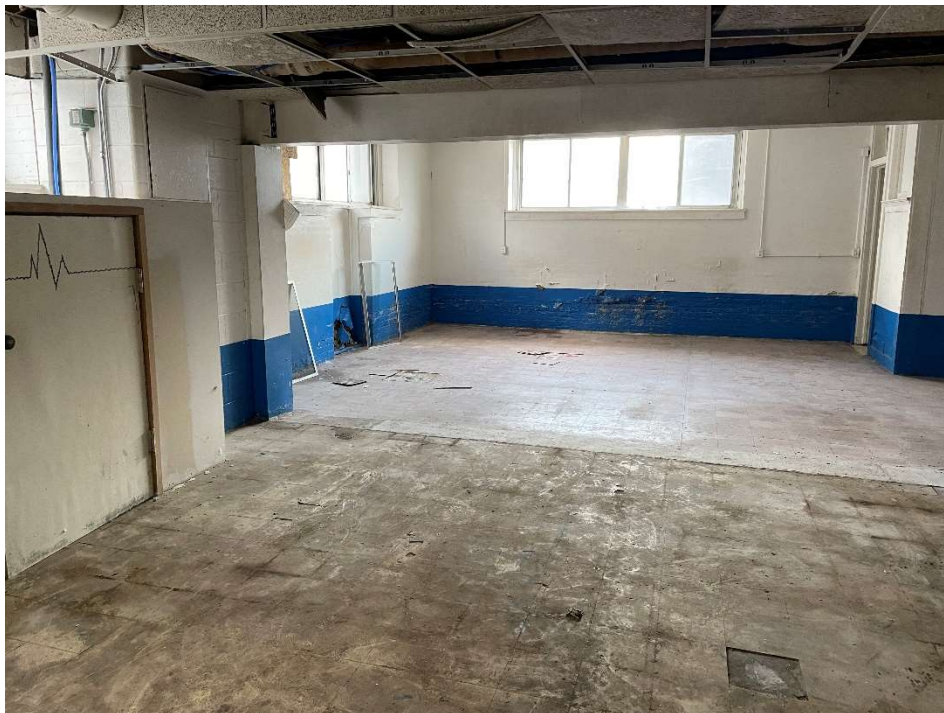
Photo 20: View of significant moisture damage on south wall of basement

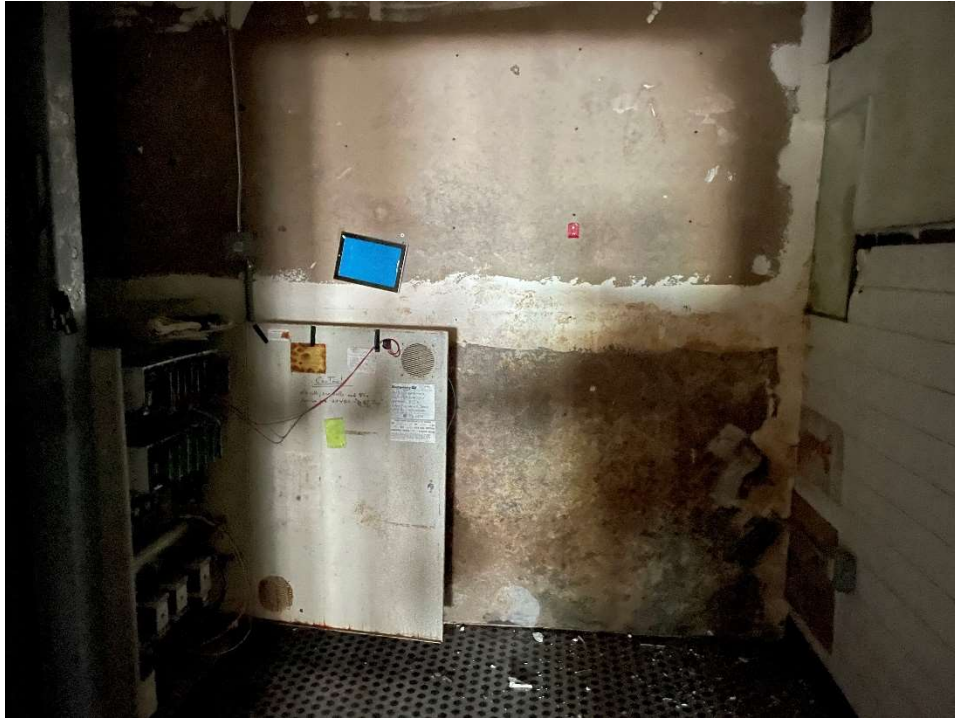
Photo 21: View of significant water damage in Room B8 in the basement

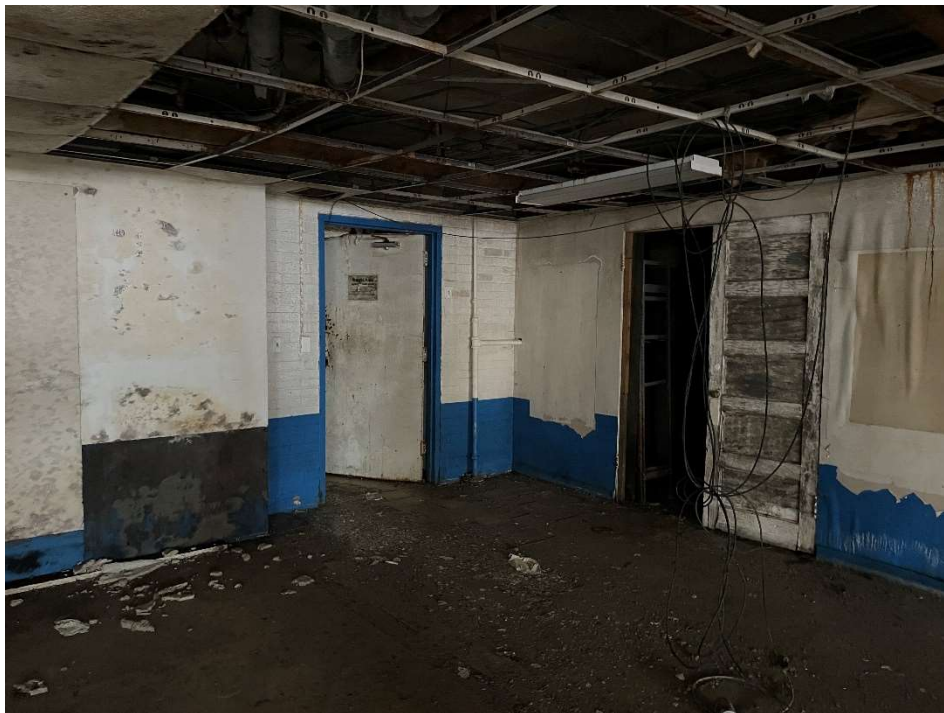
Photo 22: View of water damage and suspect microbial growth in northwest portion of basement
