Analysis of Brownfields Cleanup Alternatives

Former YMCA Building in Clinton, Iowa

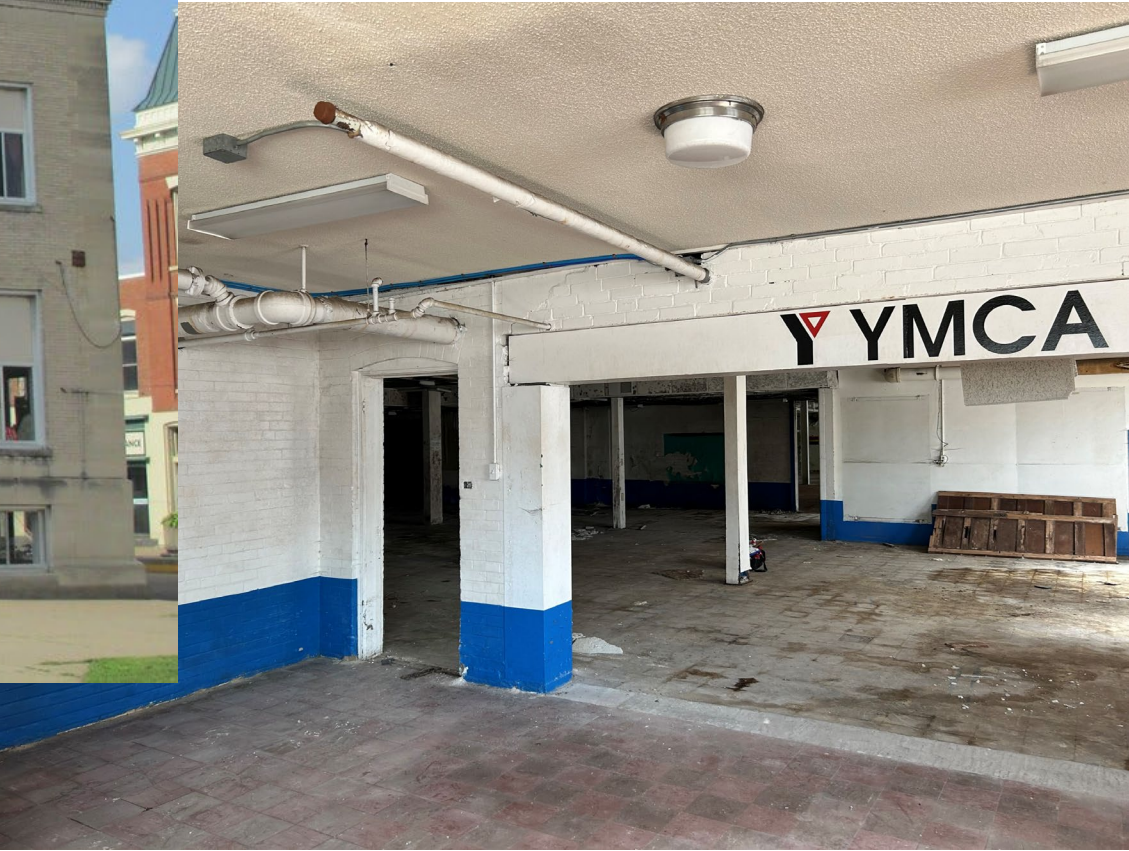
Building Sections

A 1905 three-story with basement

B1 1905 two-story with basement

B2 1961 two-story addition with basement

C1 1980 one-story addition

C2 1978 three-story addition with sub-level

C3 1978 three-story addition with sub-level

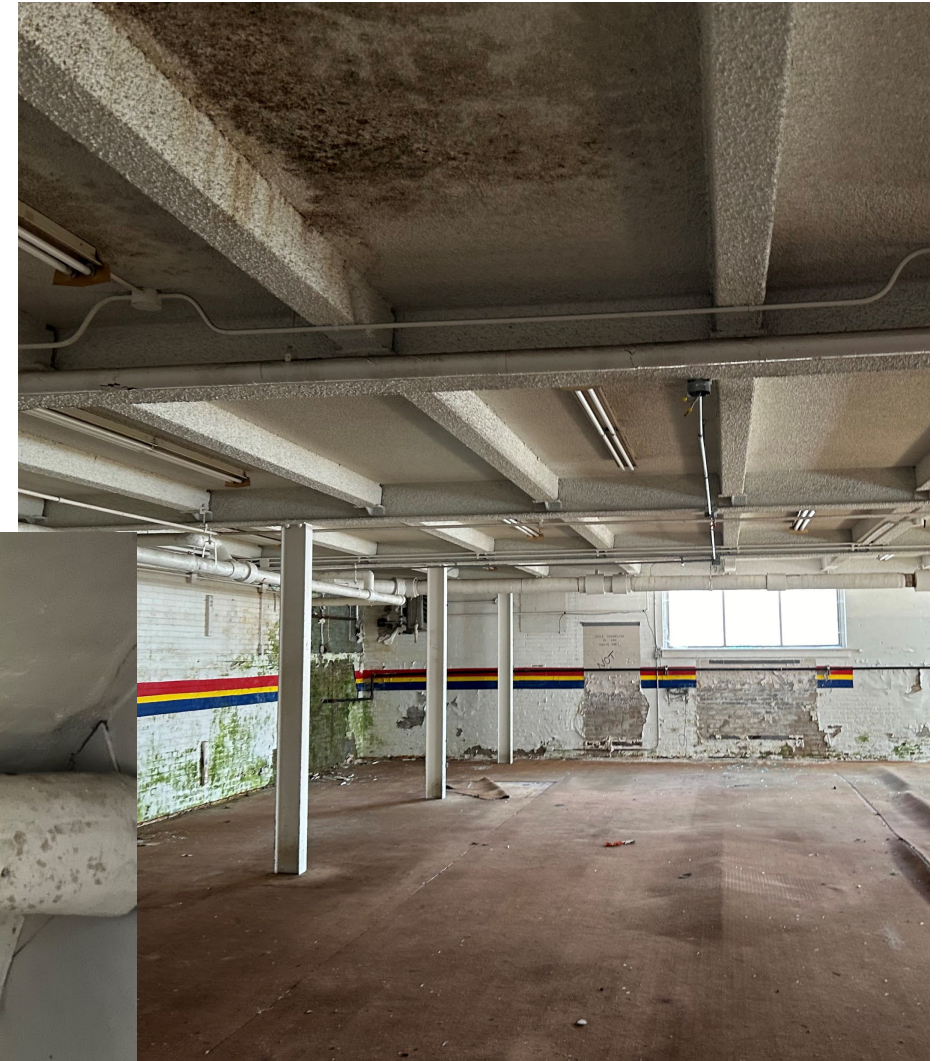
ACM Findings

- Asbestos inspections completed in 2021, 2022, and 2024.
- Asbestos detected in 71 of 407 analyzed samples.
- ACMs include: pipe insulation, mudded fittings, floor tile, floor tile mastic, linoleum, cement board, caulk, and roofing materials, etc...

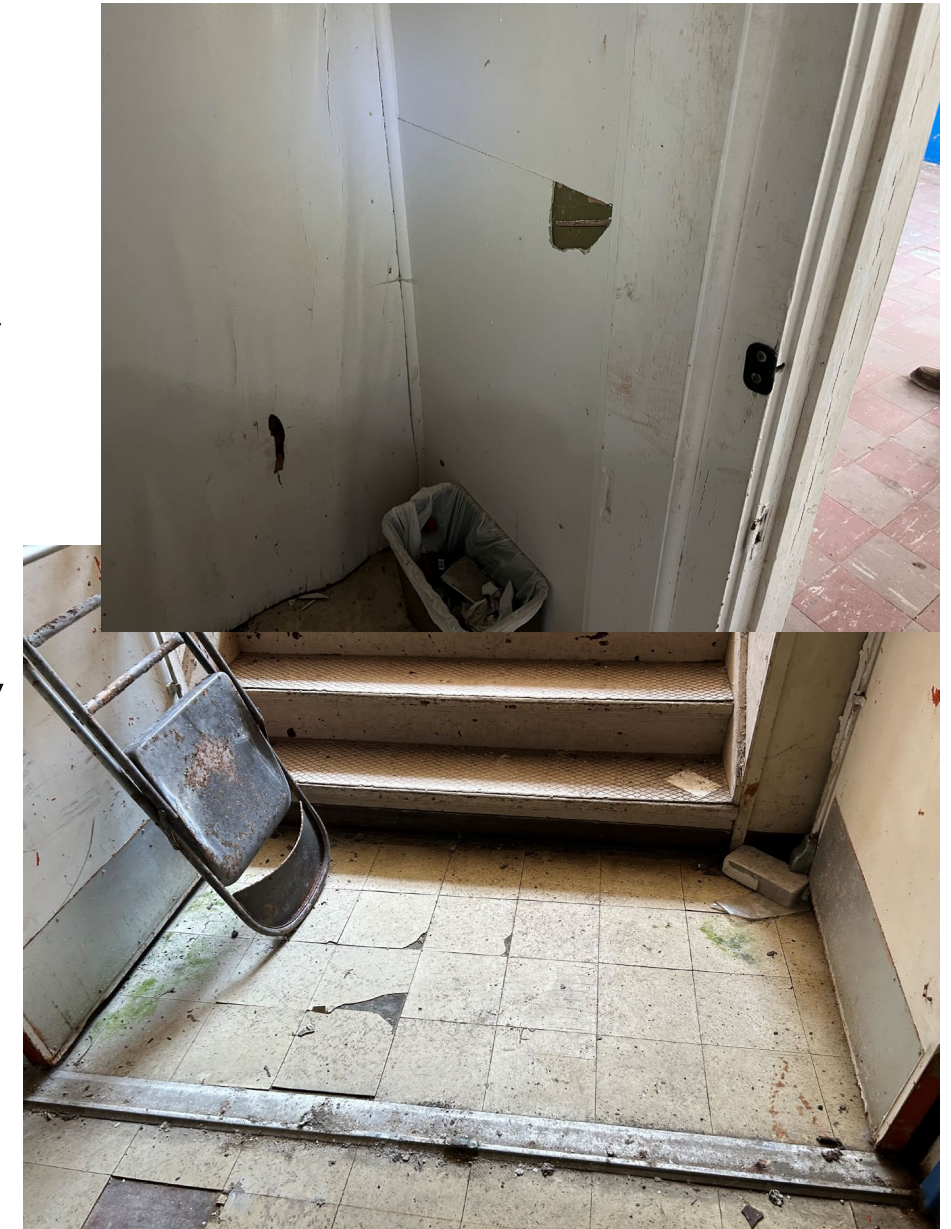
LBP Findings

- LBP screening completed in 2021.
- LBP present in multiple XRF readings.
- Not a complete inspection.

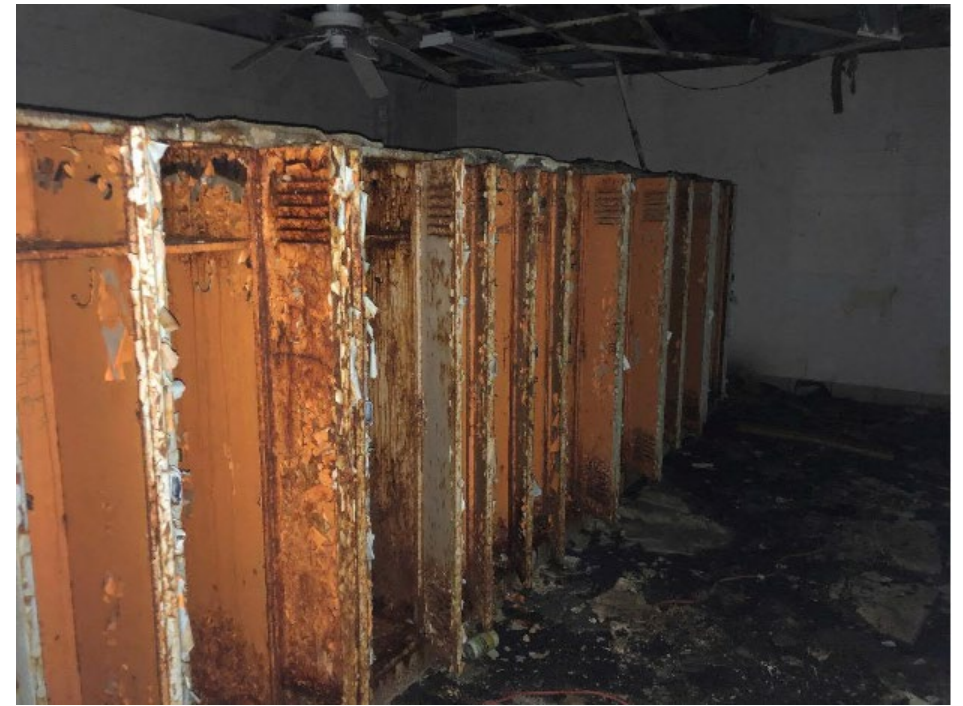
Mold Findings

- Moisture and Microbial Investigation completed in 2022.
- Air samples collected at 30 interior locations and 2 exterior locations.
- Indoor airborne fungal spore concentrations up to 210,000 spores/m³.
- Total outdoor airborne fungal spore concentrations: 5,800-6,000 spores/m³.
- Amplification and fungal growth observed.
- Surface samples collected from six locations – microbial growth confirmed on two surfaces.

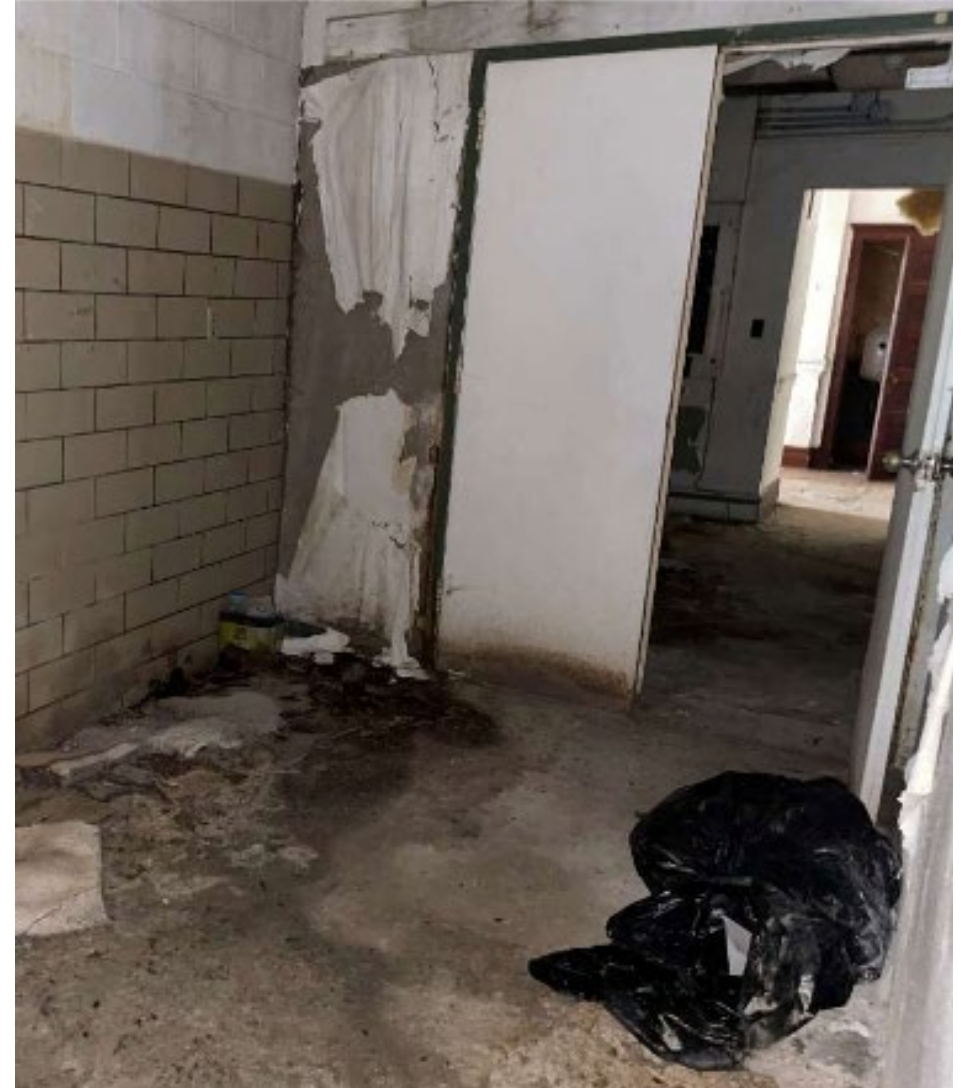
Moisture Findings

- Moisture readings of substrates indicated “wet” and “at risk” materials.
- Water staining, microbial growth, and musty odors observed.
- Roof leaks and water in structure.

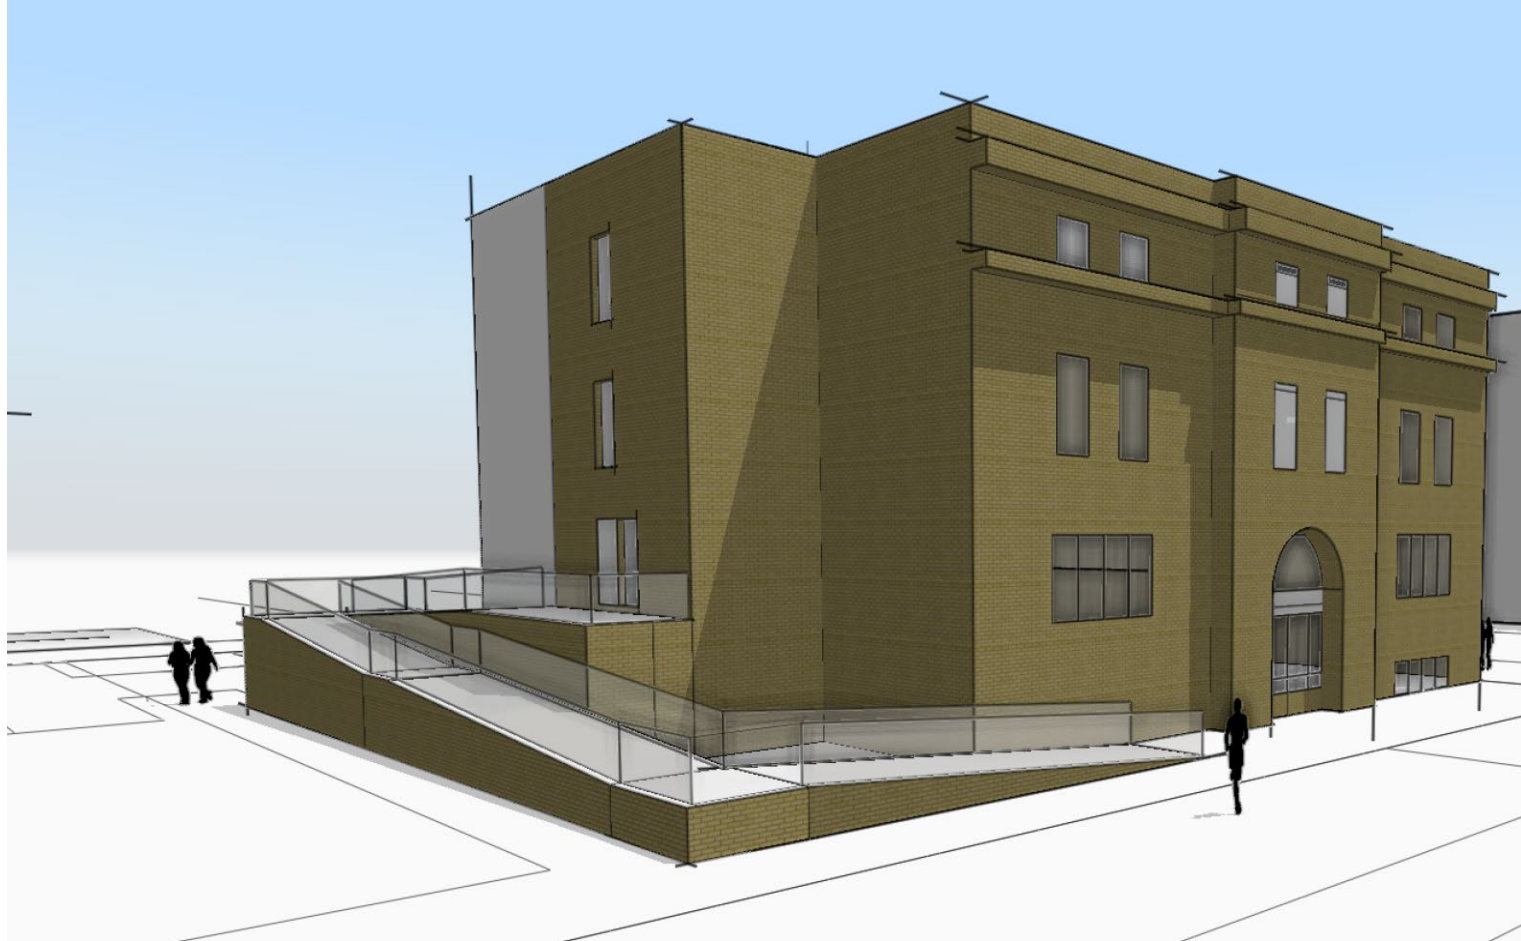
SITE REUSE OPTION 1

An architectural rendering of a three-story building with a modern, industrial aesthetic. The building features a light gray facade and a dark brown, vertically-slatted roofline. It has multiple rows of rectangular windows, some of which are partially covered by dark frames. The ground floor appears to be a commercial space with large glass doors and windows. In front of the building is a paved parking lot with several parking spaces marked. A few trees are planted along the sidewalk in front of the building. A person is walking on the sidewalk. To the right of the building, there is an outdoor seating area with blue umbrellas and tables. The sky is a clear, light blue.

- Maximum lot buildout, while maintaining neighborhood height
- Mixed use development, commercial on first floor, residential 2nd/3rd
- 40 partially enclosed parking stalls, and 62,205 square feet of floor area.
- Cost is projected to be between 15 and 21 million dollars
