August 15, 2023

Re: 1006-1008 South 4<sup>th</sup> Street and 1004, 1002, and 1000 South 4<sup>th</sup> Street

This letter is a follow up my visual assessment of the properties at the above referenced locations on August 14, 2023. It is my understanding the building at 1006-1008 South 4<sup>th</sup> Street collapsed on August 11, 2023. The building that collapsed is boxed in red in Figure 1. The assessment is in response to your request to have a licensed engineer with a structural specialty to provide a recommendation to whether the adjacent buildings pose a hazard if South 4<sup>th</sup> Street is reopened to traffic.

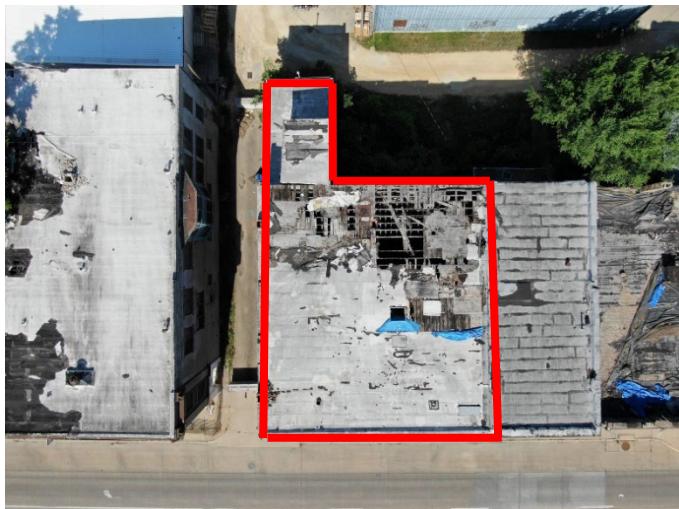
Figure 1: 1006-1008 South 4th Street Pre-Collapse.

As noted in my letter dated September 23, 2022, the building at 1006-1008 South 4<sup>th</sup> Street was in severe disrepair and had many failed structural elements upon visual inspection on September 21, 2022. These failures included missing portions of the roofing materials, including visible holes. The failed structural elements noted in my prior report likely caused the collapse of the building, resulting in South 4<sup>th</sup> Street being covered in debris. Notwithstanding the collapse, the shared wall between 1006-1008 South 4<sup>th</sup> Street and 1004 South 4<sup>th</sup> Street remains. Like the collapsed building, large portions of roofing materials on 1004 & 1002 South 4<sup>th</sup> Street are also missing, albeit without any holes seen in previous aerial photography. The deteriorated roofing leaves little to no protection from the elements and could cause a more rapid decline in the structure of 1004 South 4<sup>th</sup> Street. The collapsed building no longer provides any lateral support for the remaining exposed wall and the potential for water load on the building floors could lead to this rapid decline. The now exposed shared wall and deteriorated roofing materials pose a significant threat to the structural integrity of these buildings, beyond those noted in my original letter.

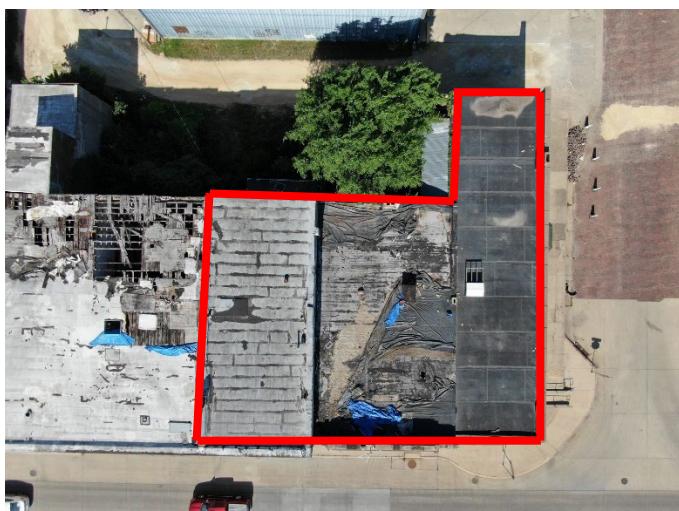
Figure 2: 1004, 1002, & 1000 South 4th Street Pre-Collapse.

The wall between 1002 and 1000 South 4<sup>th</sup> Street is also shared. There is no way to determine if this shared wall can act as an exposed exterior wall, should 1004 and 1002 South 4<sup>th</sup> Street be taken down, without going inside the buildings and performing a more detailed inspection. However, the deteriorated condition of the building, compromised structural integrity, and risk of collapse prohibit safe entry into the building and thereby precludes my ability to complete a more detailed inspection. My professional opinion of the shared wall is it was constructed as an interior wall with no consideration of being an exterior wall.

Reopening South 4<sup>th</sup> Street to traffic should only take place if the remaining buildings are knocked down to a level where a collapse will not allow debris to land on the roadway in my opinion. Removal of the

buildings can take place later, but they currently pose a threat to vehicular traffic since there is no way to ascertain how long they will be able to stand in place given the years of deterioration and water intrusion they have sustained. This is especially true now that another wall is exposed directly to the elements.
